Shipwreck-Compass®: Software for Shipwreck Corrosion Modeling and Shipwreck Corrosion Prediction

Version 9.18

Features and Functions of Shipwreck-Compass

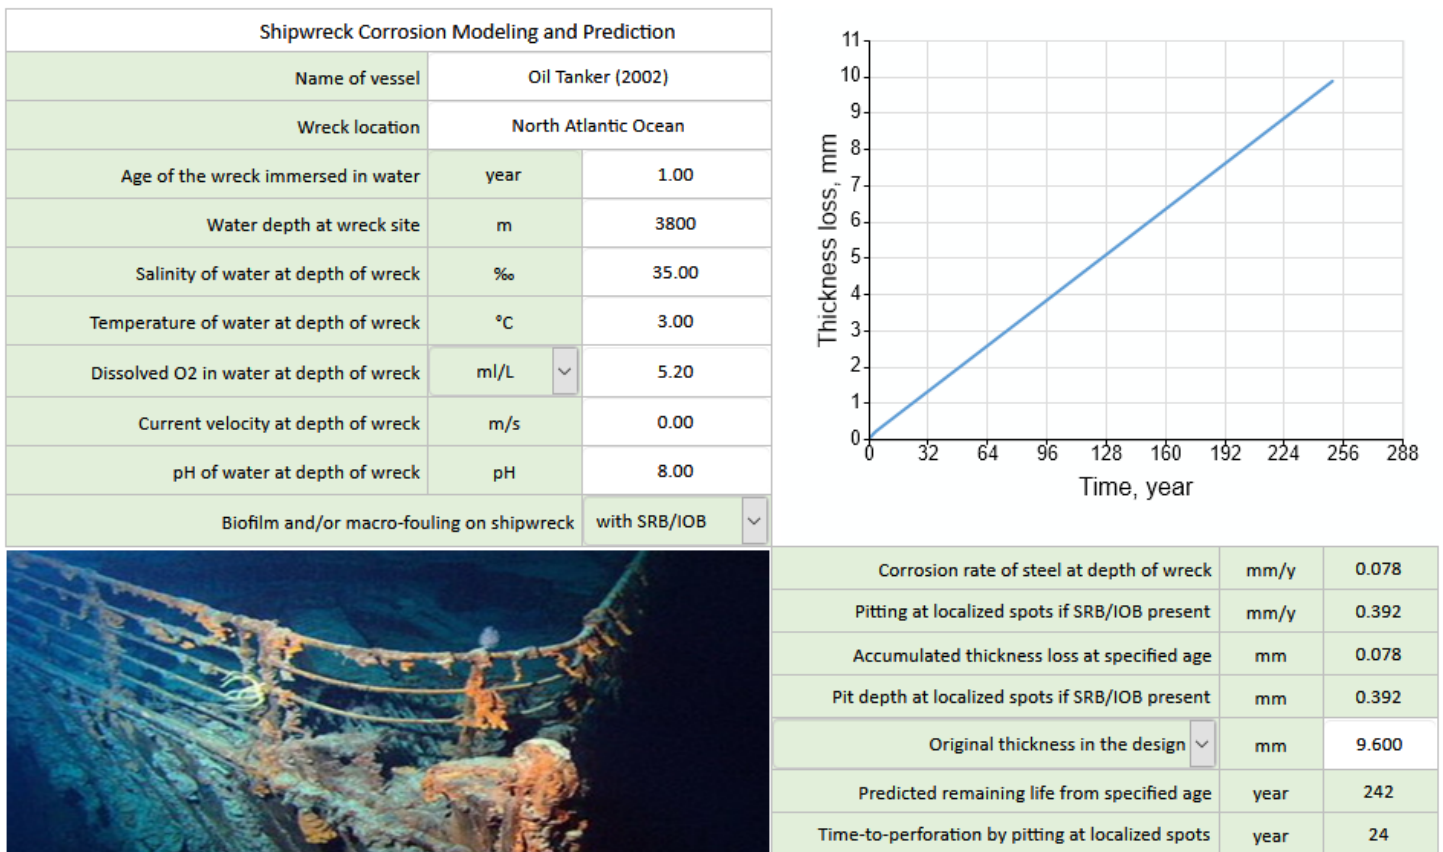
Shipwreck-Compass is the only device and OS independent software tool on the market for shipwreck corrosion modeling and corrosion prediction. Its predictive engine is based on the rigorous frameworks of thermodynamics, physical chemistry, and corrosion kinetics. This software tool models the effects of dissolved oxygen, temperature, salinity, current velocity, pH, depth of water, marine growth and microorganisms including sulphate-reducing bacteria (SRB) and iron-oxidizing bacteria (IOB) on the corrosion rate, pitting rate, the thickness loss, pit depth, the remaining life, and the time-to-perforation, as shown in Figure 1 below for an oil tanker sank in the Atlantic Ocean in 2002.

Figure 1 Shipwreck-Compass Predicts Shipwreck the Corrosion Rate, the Thickness Loss, and the Remaining Life.

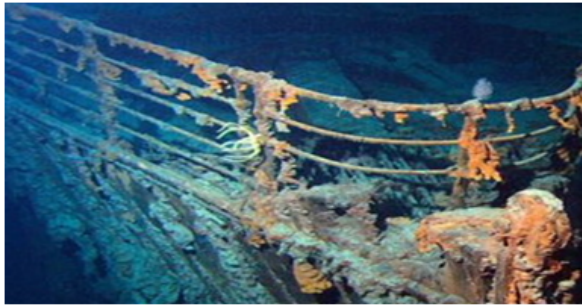
The predictive engine in Shipwreck-Compass also takes into account the effects of marine growth and microorganisms that are present in seawater environments (Figures 2a and 2b). The biofilms that form on the metal surface have the capability to influence the corrosion of the metal. The film itself can range from a microbiological slime film to a heavy encrustation of hard-shelled fouling organisms. This influence of biofilm derives from the ability of the organisms to change the local environmental variables important to corrosion such as dissolved oxygen, temperature, velocity, pH and others. For example, a heavy encrustation of bio-fouling organisms on steel immersed in seawater will often decrease the corrosion rate of the steel as long as the cover of organisms remains complete and relatively uniform. The heavy fouling layer acts as a barrier film in limiting the amount of dissolved oxygen reaching the metal surface, thus reducing the thickness loss of the

Shipwreck Corrosion Modeling and Prediction		
Name of vessel	ABC	
Wreck location	Atlantic Ocean	
Age of the wreck immersed in water	year	10.00
Water depth at wreck site	m	70
Salinity of water at depth of wreck	‰	35.00
Temperature of water at depth of wreck	°C	11.00
Dissolved O2 in water at depth of wreck	ml/L	4.60
Current velocity at depth of wreck	m/s	1.00
pH of water at depth of wreck	pH	8.00
Biofilm and/or macro-fouling on shipwreck	present

Rate of steel at depth of wreck	mm/y	0.070
Localized deep pitting unlikely	mm/y	n/a
Thickness loss at specified age	mm	1.471
Localized deep pitting unlikely	mm	n/a
Initial thickness in the design	mm	6.000
Remaining life from specified age	year	98
Localized deep pitting unlikely	year	n/a

Figure 2a: Modeling the effect of marine growth and microorganisms on corrosion.

Use the default entry of "present" if you are not sure.
 Biofilm formation and macro-fouling are expected on metal surfaces immersed in seawater except in deep sea environment where macro-fouling does not occur.
 To model the corrosion rate of a localized area not covered by marine growth or in deep sea (>1800 m depth), select "no macro-fouling" from the list.
 If sulphate-reducing bacteria (SRB) and/or iron-oxidizing bacteria (IOB) is confirmed to be present on the wreck, use this option to predict the pitting rate, the pit depth, and the time-

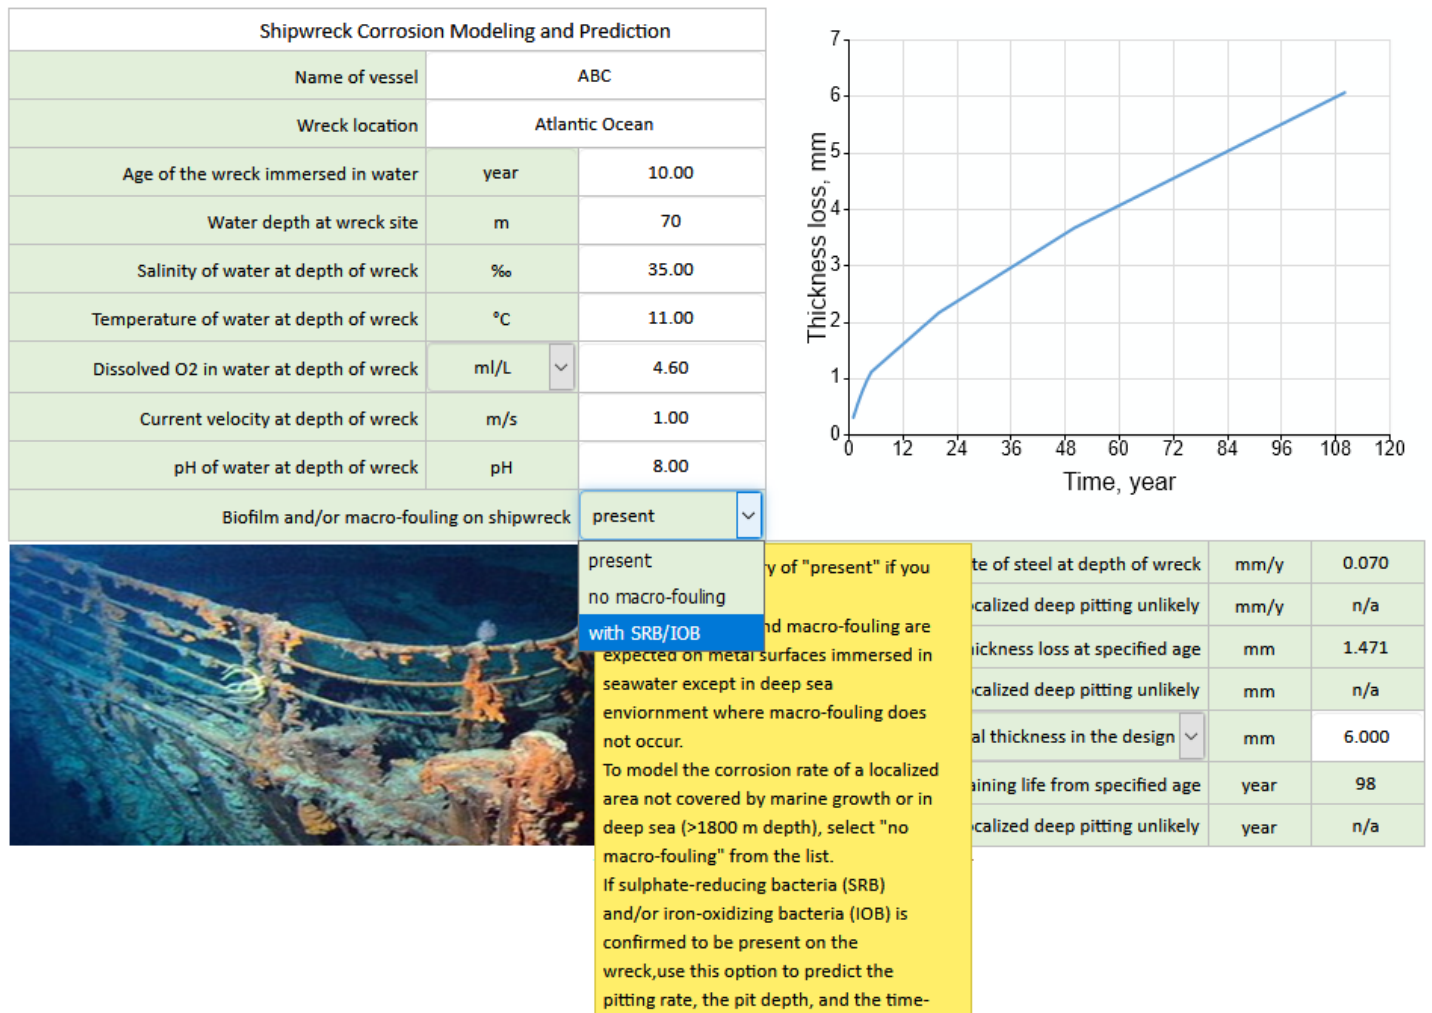
Figure 2b: Modeling the effect of marine growth and microorganisms on corrosion.

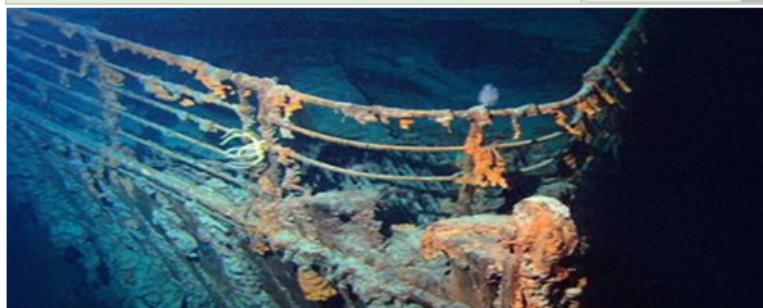
Shipwreck Corrosion Modeling and Prediction		
Name of vessel	ABC	
Wreck location	Atlantic Ocean	
Age of the wreck immersed in water	year	10.00
Water depth at wreck site	m	70
Salinity of water at depth of wreck	‰	35.00
Temperature of water at depth of wreck	°C	11.00
Dissolved O2 in water at depth of wreck	ml/L <input type="text" value=""/>	4.60
Current velocity at depth of wreck	ml/L	1.00
pH of water at depth of wreck	mg/L	8.00
	ppm	
Biofilm and/or macro-fouling on shipwreck	present	<input type="text" value=""/>

Corrosion rate of steel at depth of wreck	mm/y	0.070
No SRB/IOB, localized deep pitting unlikely	mm/y	n/a
Accumulated thickness loss at specified age	mm	1.471
No SRB/IOB, localized deep pitting unlikely	mm	n/a
Original thickness in the design	mm	6.000
Predicted remaining life from specified age	year	98
No SRB/IOB, localized deep pitting unlikely	year	n/a

Figure 3 Dissolved Oxygen Concentration and Shipwreck Corrosion Prediction

Users can enter the dissolved oxygen concentration in any unit without the need to do manual conversion (Figure 3). To predict the remaining life, users can either enter the original thickness in the design (if known) or the remaining thickness (if measured), as shown in Figure 4.

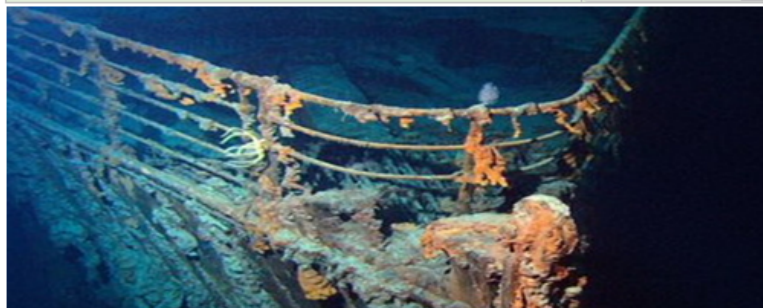
Shipwreck Corrosion Modeling and Prediction		
Name of vessel	ABC	
Wreck location	Atlantic Ocean	
Age of the wreck immersed in water	year	10.00
Water depth at wreck site	m	70
Salinity of water at depth of wreck	‰	35.00
Temperature of water at depth of wreck	°C	11.00
Dissolved O2 in water at depth of wreck	ml/L <input type="text" value=""/>	4.60
Current velocity at depth of wreck	m/s	1.00
pH of water at depth of wreck	pH	8.00
Biofilm and/or macro-fouling on shipwreck	present	<input type="text" value=""/>

Corrosion rate of steel at depth of wreck	mm/y	0.070
No SRB/IOB, localized deep pitting unlikely	mm/y	n/a
Accumulated thickness loss at specified age	mm	1.471
No SRB/IOB, localized deep pitting unlikely	mm	n/a
Original thickness in the design	mm	6.000
Original thickness in the design	year	98
Remaining thickness before sinking	year	n/a

Figure 4 Remaining Life Prediction of Shipwreck

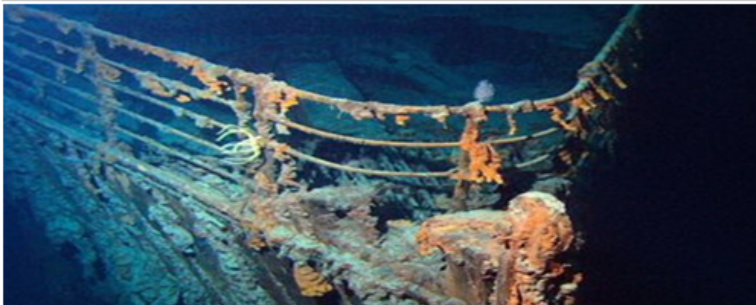
Shipwreck Corrosion Modeling and Prediction		
Name of vessel	USS Monitor (1862)	
Wreck location	Cape Hatteras, NC, USA	
Age of the wreck immersed in water	year	144.00
Water depth at wreck site	m	70
Salinity of water at depth of wreck	‰	35.00
Temperature of water at depth of wreck	°C	7.00
Dissolved O2 in water at depth of wreck	ppm	6.40
Current velocity at depth of wreck	m/s	0.00
pH of water at depth of wreck	pH	8.20
Biofilm and/or macro-fouling on shipwreck	present

Corrosion rate of steel at depth of wreck	mm/y	0.037
No SRB/IOB, localized deep pitting unlikely	mm/y	n/a
Accumulated thickness loss at specified age	mm	5.431
No SRB/IOB, localized deep pitting unlikely	mm	n/a
Original thickness in the design	mm	25.400
Predicted remaining life from specified age	year	538
No SRB/IOB, localized deep pitting unlikely	year	n/a

Figure 6 Shipwreck-Compass Prediction of shipwreck corrosion and remaining life for the USS Monitor (1862)

Ultrasonic thickness measurements conducted in 2007 (144 years after sinking) on the outer turret plates at eight locations near the gun openings showed a thickness loss of about 5 mm. This gives an average measured corrosion rate of 0.035 mm/y. Figure 6 shows the prediction results from Shipwreck-Compass. The predicted corrosion rate is 0.037 mm/y and the predicted thickness loss is 5.4 mm.

Measured using ultrasonic thickness gauge	Predicted using Shipwreck-Compass
Thickness loss, mm	5 mm	5.4 mm
Corrosion rate, mm/y	0.035 mm/y	0.037 mm/y
