# “Sea Diamond” Wreckage—12 Years after the Fatal Maritime Accident, the Vessel Remains an Environmental Concern

The present study was accomplished to fulfill the requisition of the Appeal Court of the city of Piraeus. According to the Court's Decision, an environmental impact assessment should be made for the ongoing condition of the wreckage along with a study of the corrosion evolution process and a provision of the hull's endurance should be estimated. The wreckage was sounded out, surveyed thoroughly by means of an ROV device immersed ad hoc. Extended videos and photo shots were taken and the exact position of the vessel depicted analytically on a sea contour depth chart. Hull corrosion, sea column & sea bottom sediment sampling carried out for the analysis of hazardous compounds PAHs, TPHs, PCBs and heavy metals in June and July of 2019. Fish and oyster tissues were analyzed in the lab for heavy metals' detection. A great concern was given for (Cd) & (Pb) concentration in sea column nearby wreck. A report of about 1000 pages of the methodology & results was handed over to the Appeal Court of which merely partial significant segments are presented herein. The technical report

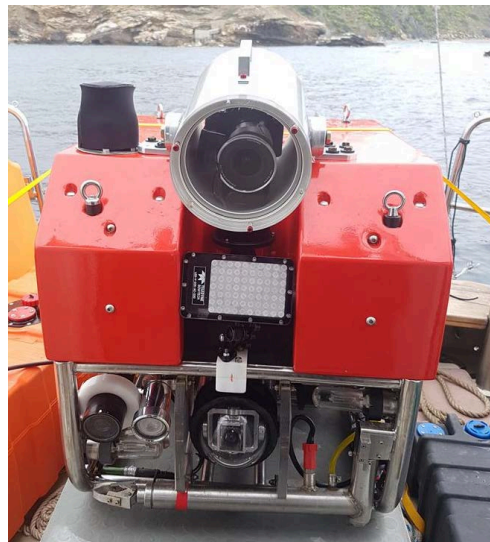
**Figure 1.** ROV “super Achilles” at a close range.

A thorough underwater observation and partially inspection of “Sea Diamond” hull and super-structures took place by means of a highly maneuverable submerged robot, remotely operated (ROV) named “super Achilles” (**Figure 1**). The ROV was of observation class II, manufactured by COMEX S.A., with specifications to satisfy all IMCA standards. The vehicle, equipped with a main and an auxiliary camera of low brightness with wide angle lens 0.001 LUX, was connected to the surface supporting vessel with a single coaxial umbilical. Sensors and lights supplemented the equipment. An imaging sonar (Tritech, model ST525V) and two (2) real time video channels supporting a professional box Sony Effio™ 960 h @ 0.001 Lux (F1.2) video camera. The ROV was being operated by means of a surface control unit connected to a computer, (RS 232C), sending simultaneously heading, altitude and depth data (Ultra Short BaseLine system) *i.e.* underwater acoustic positioning. Four (4) asynchronous 3.5 HP thrusters transmit maneuverability of the overall 130 kg weight, (incl. a stainless-steel chassis structure) which supports the potentially achievable maximum speed of 3.5 knots.

All power needed is supplied by a transformer of 190/210/230/250 Volts output. The INOX skeleton is enforced with PVC foam framework to support surface floating and good buoyancy. Tsunamis 99 software deployed for vectorized navigation charts production of high quality by Navigation Dynamics. The seabed around the wreckage was depicted analytically by deploying a side sonar 675 kHz scanner of Tritech, (SeaKing Towfish model) along with a Tritech Seanet Pro software. All the above-mentioned equipment was mounted on the vessel “Oceanis” (**Figure 2**).

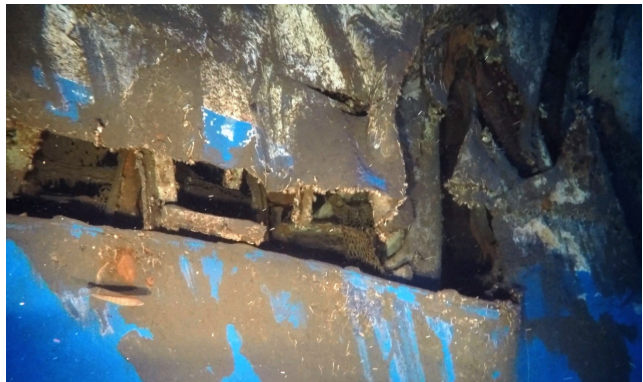
ship lies on the axis 144 degrees SE astern and 324 degrees NW at bow/ahead. Sea bed inclination is directing southwest and fluctuates between 11 and 16 degrees. Cracks were reported, located on decks No 3 & 4 (**Figure 6** & **Figure 7**). Vessel inclination is 7 degrees astern and 12 degrees to the starboard. The minimum depth above the ship bridge is 86 m. The maximum depth at the portside of the bow is 147 m. The water body temperature against the depth was measured by ROV embedded device. The results were deployed for the hull's corrosion model.

**Figure 6.** Horizontal/longitudinal crack/rift of Deck #3 located in between structural transversal frame #114 and #137.

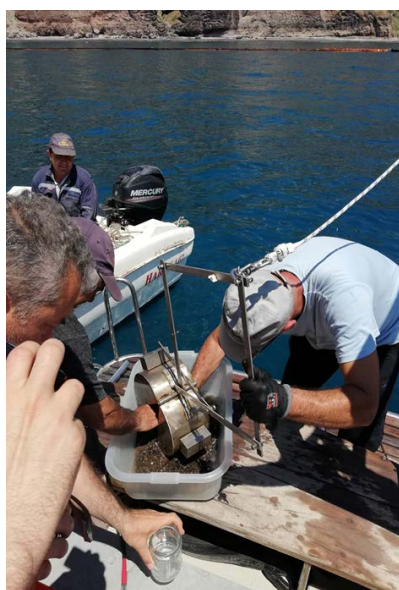
**Figure 8.** Grab sampler in action collecting seabed sediment (Thira island).

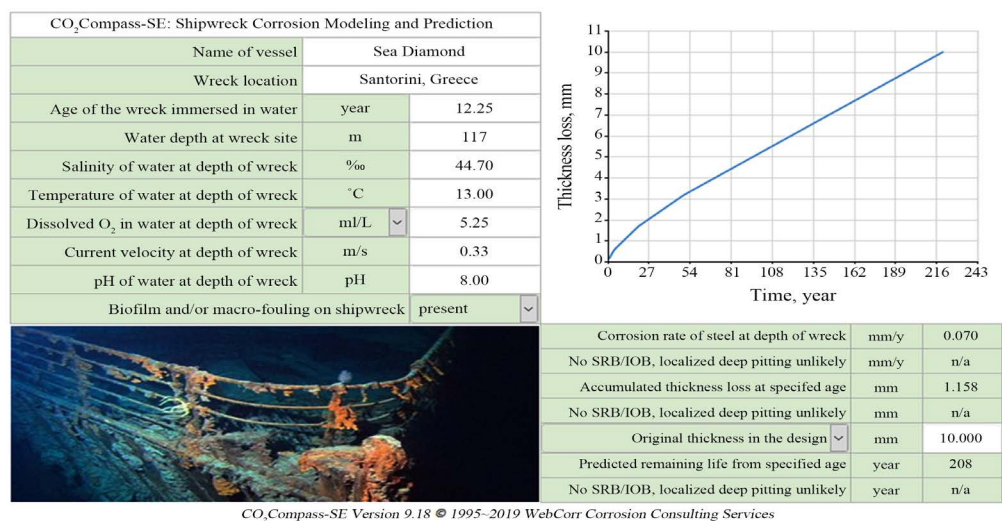
The predicted corrosion rate is estimated to be  $0.07 \text{ (mm}\cdot\text{y}^{-1}\text{)}$  which implies that carbon steel structures such as hull plates, deck plates and superstructural plates have undergone 1.158 mm thickness overall loss, over the past 12.25 years due to seawater corrosion. The remaining life (from 5th of July 2019 onwards) for the 10 mm thickness plate is 208 years, meaning that the superstructure, deck and hull plates given the original design thickness of 10 mm will be consumed by seawater corrosion in 208 years (Figure 16, Figure 17). The above under the assumption of a prevailing water current velocity of  $33 \text{ (cm}\cdot\text{s}^{-1}\text{)}$ .

**Figure 16.** Prediction results when biofilm and/or macro-fouling are present but without SRB/IOB.

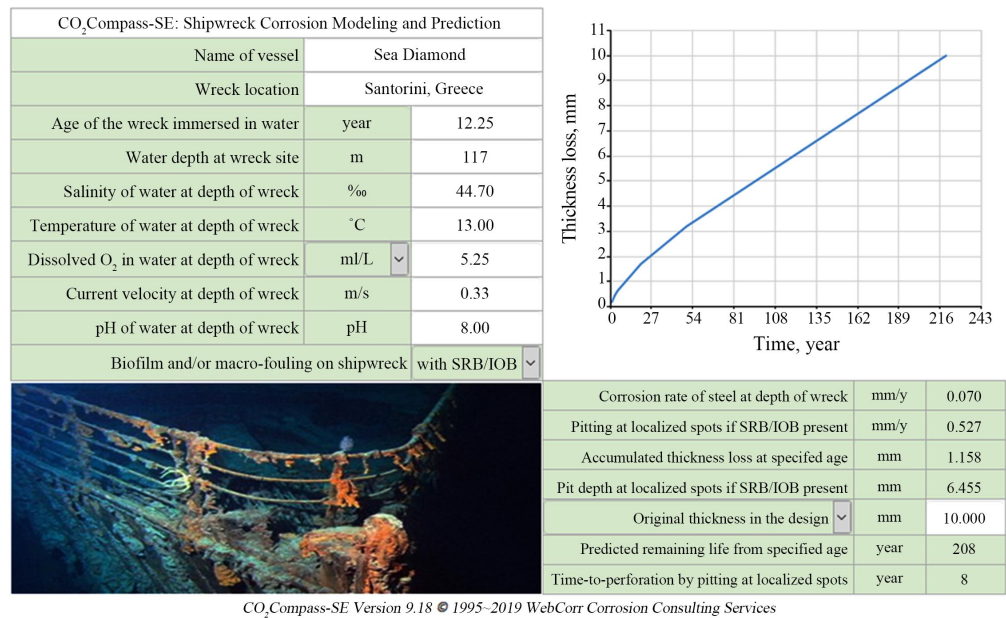
Perforation of deck plates at localized spots if -and only if SRB/IOB are present (0 - 8 years)  
 Perforation of superstructure at localized spots if and only if SRB/IOB are present (0 - 12 years)  
 Perforation of hull plate at localized spots if and only if SRB/IOB are present (8 - 38 years)  
 Collapse and disintegration of internal decks and walls (83 - 95 years)  
 The loss of all structures above the hull (108 - 183 years)  
 Exposure of all of heavy mechanical equipment in the bowels of the ship (e.g., boilers, turbines core parts etc.) (208 - 308 years)  
 Fracturing and collapse of the hull plates (208 - 308 years)  
 Exposure of the double bottom hull (295 years)  
 Final extinction of the remaining resident structures (420 years and beyond)

**Figure 17.** Prediction results when SRB/IOB are present.

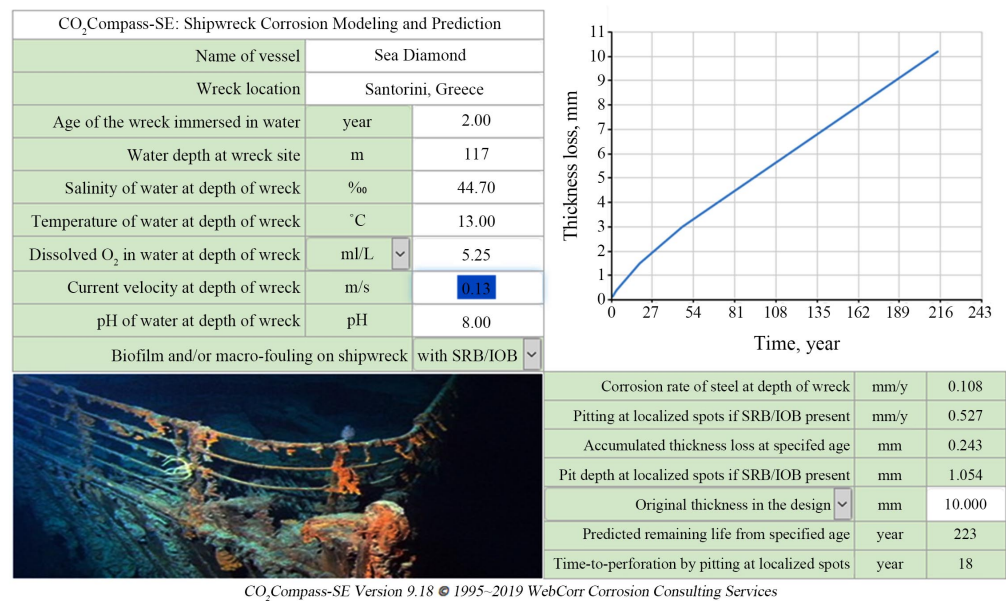
Corrosion prediction at water current velocity of  $13 \text{ (cm}\cdot\text{s}^{-1}\text{)}$  in 2009 with SRB/IOB presence, indicates that the predicted remaining life of the structures due to sea corrosion is 223 year from 2009 onwards (Figure 18). Corrosion model results can be summarized below:

**Figure 18.** Corrosion prediction at water velocity of 13 (cm·s<sup>-1</sup>) in 2009 with SRB/IOB presence.
